**ASTM E 90 SOUND TRANSMISSION LOSS
TEST REPORT**

SERIES/MODEL: 1650 Polyvinyl Chloride (PVC)

TYPE: Double Hung Window

Report No: D8200.01-113-11
Test Date: 05/27/14
Report Date: 06/11/14
Record Retention End Date: 05/27/18

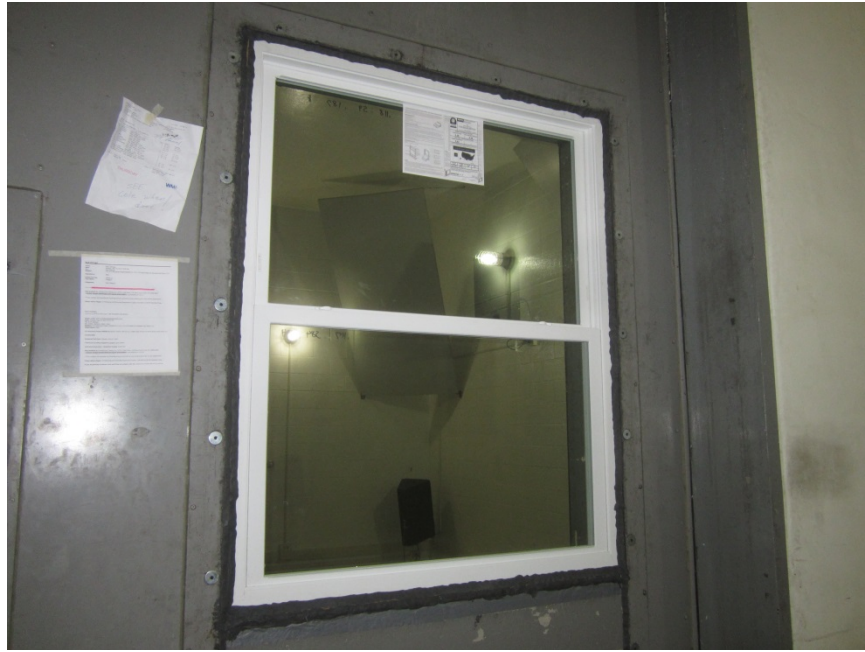
Receive Room View of Installed Specimen

A filler wall-reducing element was used to adjust the test opening size. The reducing element consisted of two separate 2x6 wood frames filled with concrete to reduce the test opening size to accommodate the test specimen. A dense neoprene gasket was placed between the two wood and concrete frames. The window was placed on an isolation pad in the new test opening. Duct seal was used to seal the perimeter of the window to the test opening on both sides. The interior side of the window frame, when installed, was approximately 1/4" from being flush with the receiving room side of the filler wall. A stethoscope was used to check for any abnormal air leaks around the test specimen prior to testing. The sashes were opened and closed at least five times prior to testing.

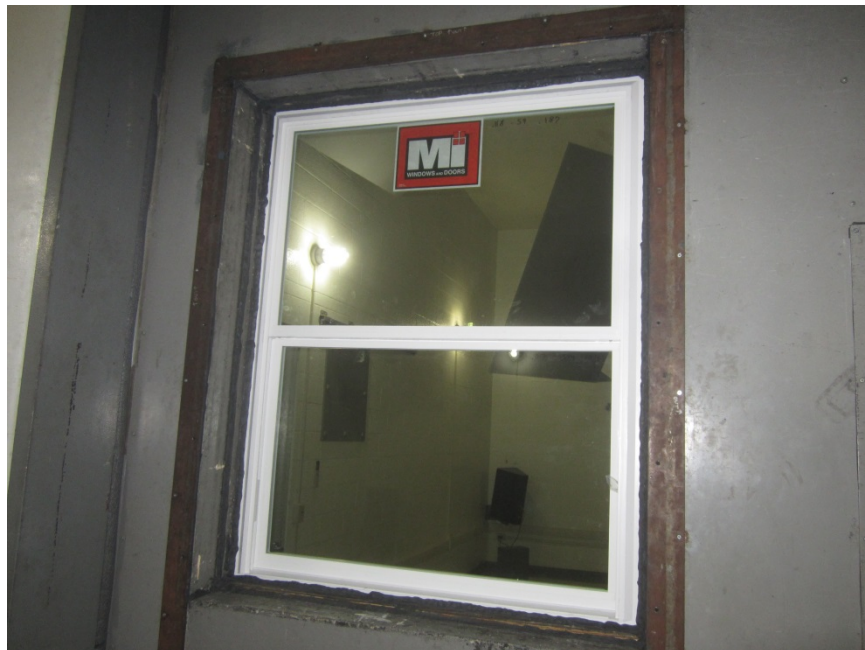
Source Room View of Installed Specimen
