**AAMA 1801 SOUND TRANSMISSION LOSS  
TEST REPORT**

**MI WINDOWS AND DOORS, INC.**

**SERIES/MODEL: 185/3185 SP**

Report No: 71965.01-113-11  
Test Dates: 04/20/07  
04/23/07  
Report Date: 05/03/07  
Expiration Date: 04/23/11

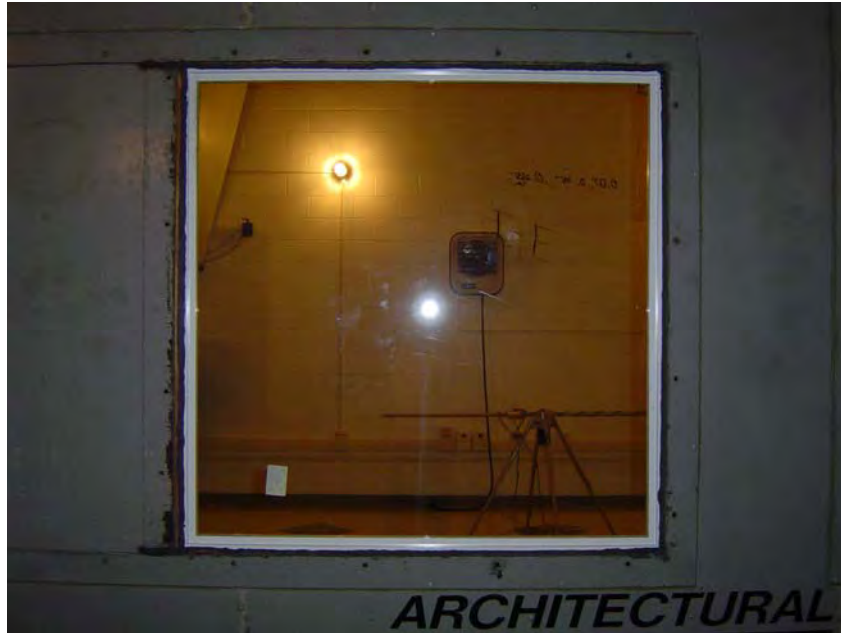
**Sample Installed in Test Chamber, Receive Room View**

Sample A had no nailing flange, and was placed on a foam isolation pad in the test opening, with the interior side of the window frame, when installed, was approximately 1/4" from being flush with the receiving room side of the filler wall.

Duct seal was used to seal the perimeter of window samples A and B to the test opening on both sides. A stethoscope was used to check for any abnormal air leaks around the test specimen prior to testing.

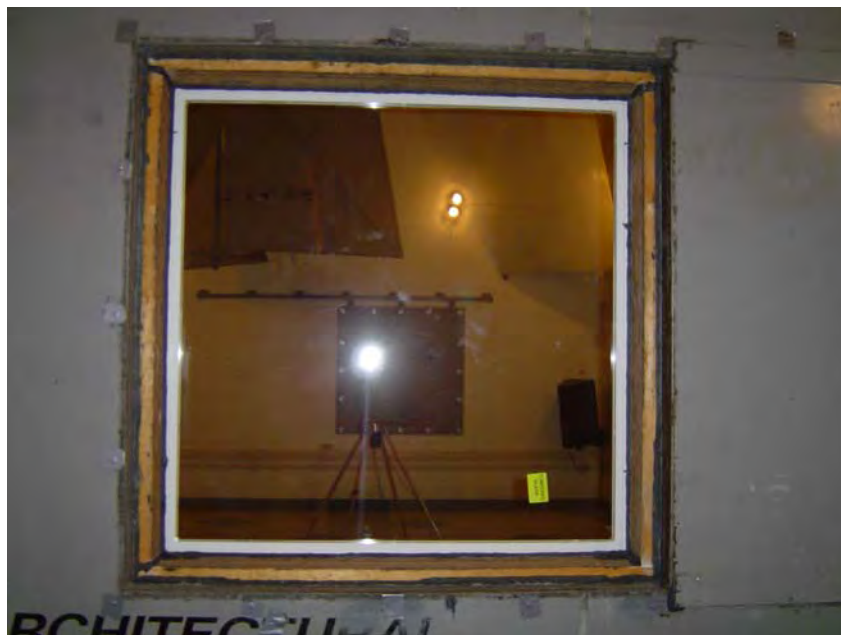
**Sample Installed in Test Chamber, Source Room View**

Sample B was mounted with the nailing flange flush to the source side of the opening, and the frame was placed on foam isolation pads in the test opening.
