**ASTM E 90 SOUND TRANSMISSION LOSS  
TEST REPORT**

**MI WINDOWS AND DOORS, INC.**

**SERIES/MODEL: EC-140**

**TYPE: Awning Window**

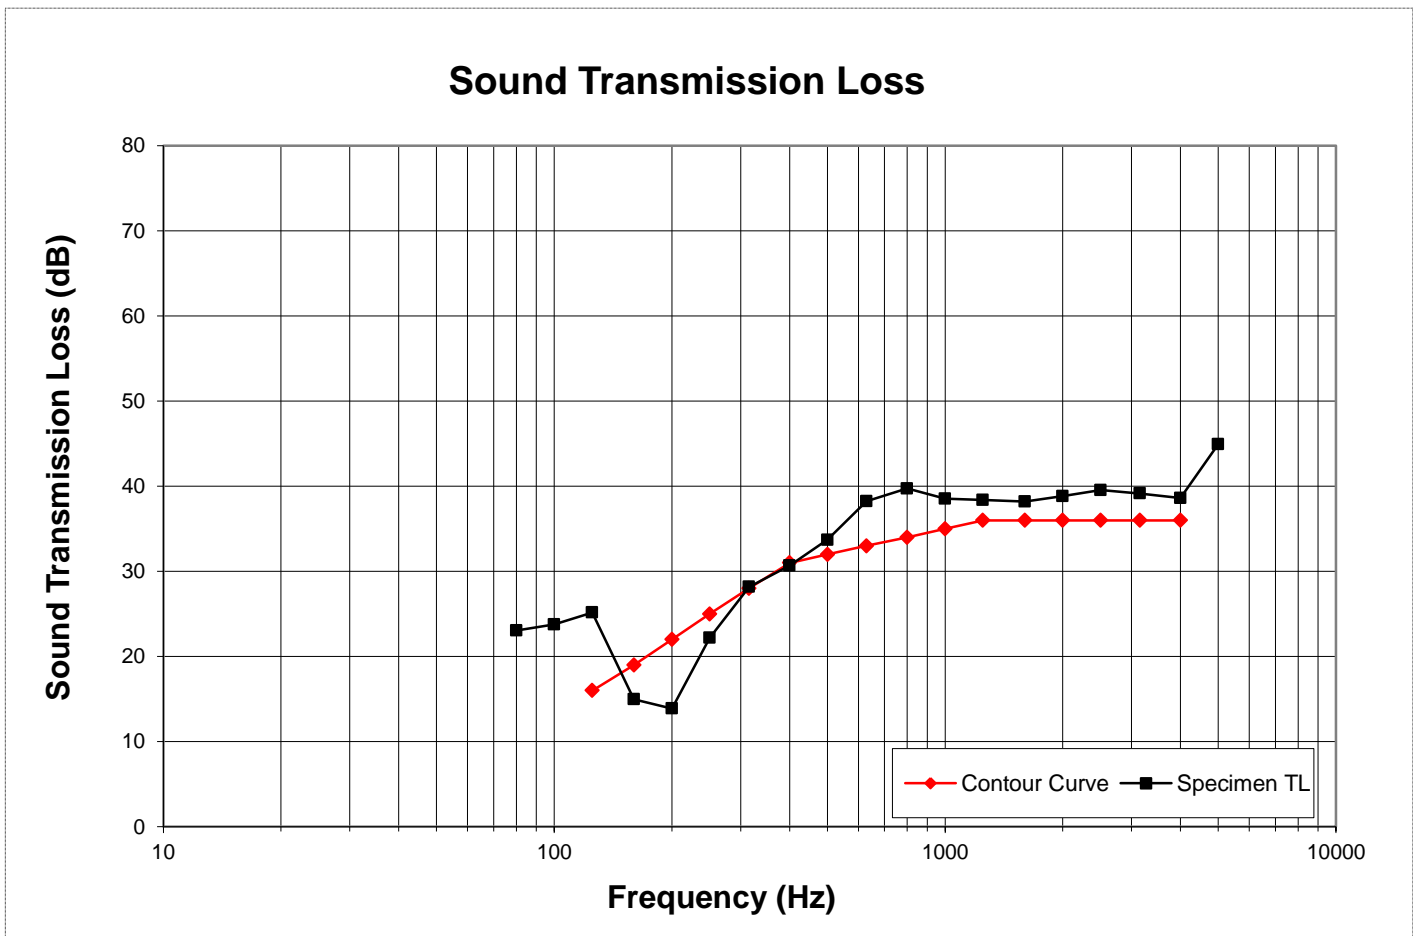
**SOUND TRANSMISSION LOSS**  
ASTM E 90

<b>Test Date</b>	03/07/13		
<b>ATI No.</b>	C6464.01A		
<b>Client</b>	MI Windows and Doors, Inc.		
<b>Specimen</b>	Series/Model: EC-140, awning window with 1-1/8" IG (1/8" annealed exterior, 13/16" air space, 3/16" annealed interior)		
<b>Operator</b>	Kurt Golden - Craig Fox		
<b>Sample Area</b>	0.90 m <sup>2</sup>		
<b>Filler Area</b>	12.09 m <sup>2</sup>		
	Source	Receive	Sample
<b>Temp C</b>	21	20	21
<b>RH %</b>	47	47	47

Note: To obtain the Sound Transmission Class (STC), read the Sound Transmission Loss of the contour curve at 500 Hz. The sum of the deficiencies below the contour curve cannot exceed 32. The maximum deficiencies at any one frequency cannot exceed 8.

**STC Rating**      **32**      *(Sound Transmission Class)*  
**Deficiencies**    **15**      *(Number of deficiencies versus contour curve)*  
**OITC Rating**    **25**      *(Outdoor Indoor Transmission Class)*

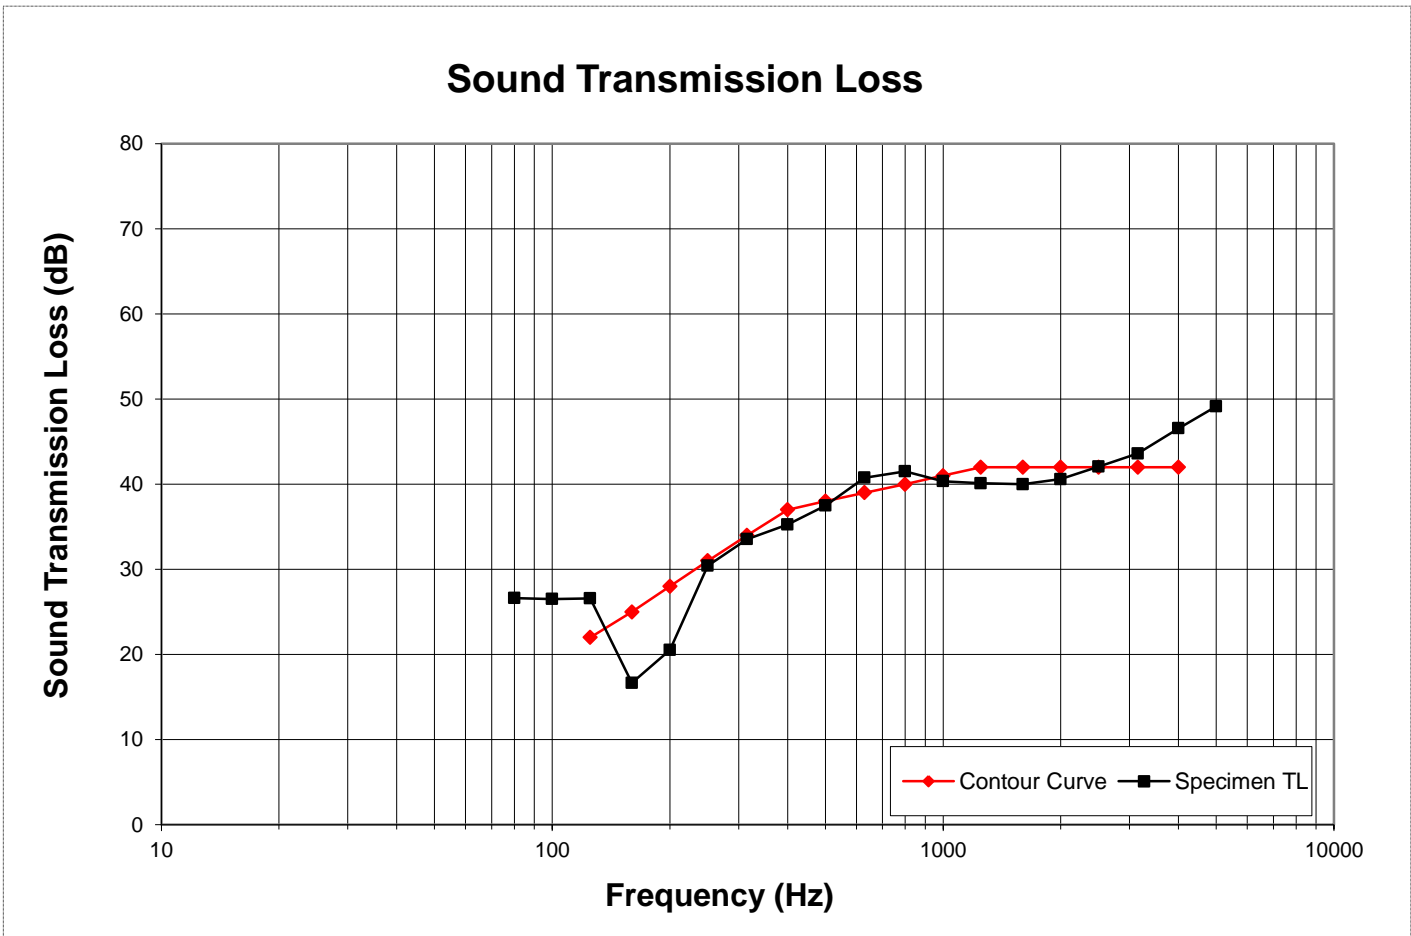
**SOUND TRANSMISSION LOSS**  
ASTM E 90

<b>Test Date</b>	03/07/13		
<b>ATI No.</b>	C6464.01B		
<b>Client</b>	MI Windows and Doors, Inc.		
<b>Specimen</b>	Series/Model: EC-140, awning window with 1-1/8" IG (2.7 mm / 0.030" Solutia Q series / 2.7 mm laminated exterior, 11/16" air space, 3/16" annealed interior), Glass temperature 75°F		
<b>Operator</b>	Kurt Golden - Craig Fox		
<b>Sample Area</b>	0.90 m <sup>2</sup>		
<b>Filler Area</b>	12.09 m <sup>2</sup>		
	Source	Receive	Sample
<b>Temp C</b>	22	21	21
<b>RH %</b>	46	45	45

Note: To obtain the Sound Transmission Class (STC), read the Sound Transmission Loss of the contour curve at 500 Hz. The sum of the deficiencies below the contour curve cannot exceed 32. The maximum deficiencies at any one frequency cannot exceed 8.

**STC Rating**      **38**      *(Sound Transmission Class)*  
**Deficiencies**      **25**      *(Number of deficiencies versus contour curve)*  
**OITC Rating**      **29**      *(Outdoor Indoor Transmission Class)*

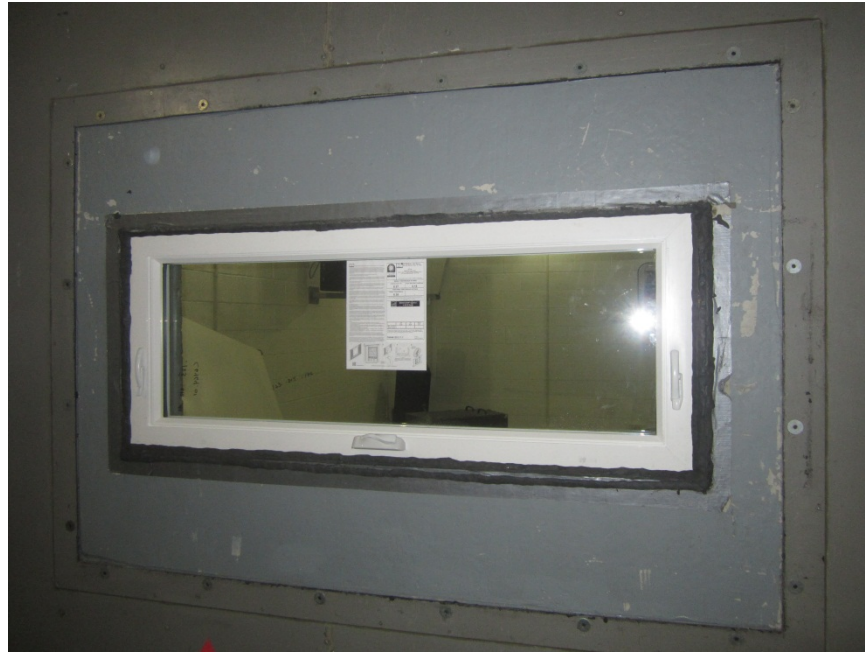
**Receive Room View of Installed Specimen**

A filler wall reducing element was used to reduce the test opening size. The reducing element consisted of two separate 2x6 wood frames filled with concrete to reduce the test opening size to 59-1/2" wide by 24-1/8" high. A dense neoprene gasket was placed between the two wood and concrete frames. The window was placed on an isolation pad in the new test opening. Duct seal was used to seal the perimeter of the window to the test opening on both sides. The interior side of the window frame, when installed, was approximately 1/4" from being flush with the receiving room side of the filler wall. A stethoscope was used to check for any abnormal air leaks around the test specimen prior to testing. The vent was opened and closed at least five times prior to testing.

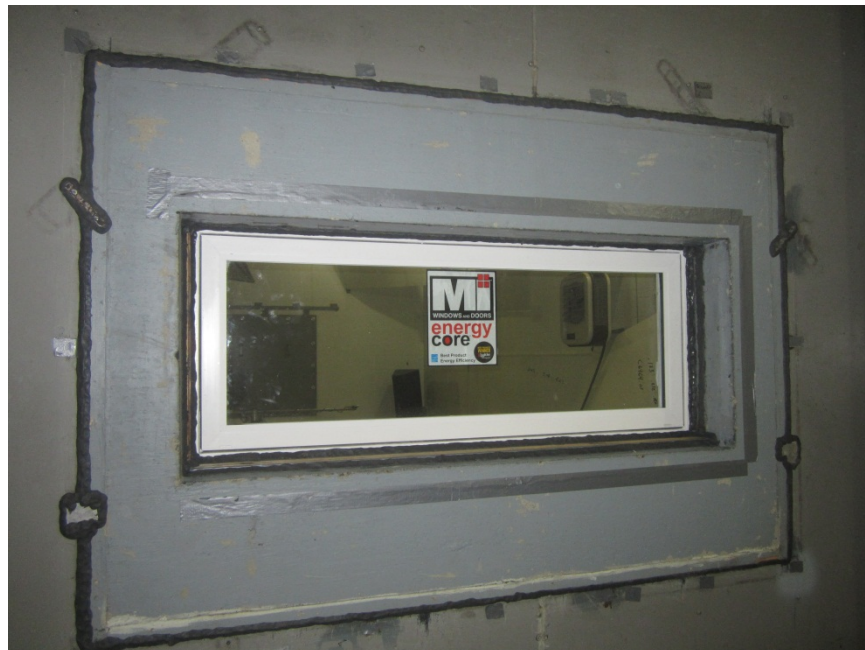
**Source Room View of Installed Specimen**
