### ASTM E 90 SOUND TRANSMISSION LOSS TEST REPORT

#### MI WINDOWS AND DOORS, INC.

**SERIES/MODEL: EC-150**

**TYPE: Single Hung Window**

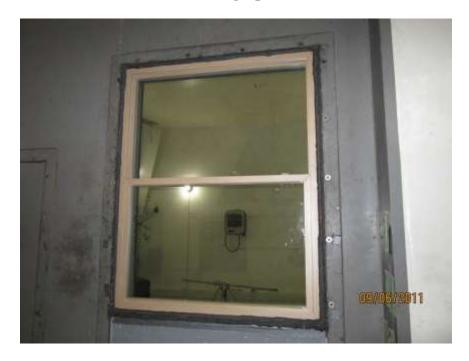
**Receive Room View of Installed Test Specimen**

A filler wall reducing element was used to reduce the test opening size. The reducing element consisted of two separate 2x6 wood frames filled with concrete to reduce the test opening size to 47-3/4" wide by 59-1/2" high. A dense neoprene gasket was placed between the two wood and concrete frames. The window was placed on an isolation pad in the new test opening. Duct seal was used to seal the perimeter of the window to the test opening on both sides. The interior side of the window frame, when installed, was approximately 1/4" from being flush with the receiving room side of the filler wall. A stethoscope was used to check for any abnormal air leaks around the test specimen prior to testing. The sash was opened and closed at least five times prior to testing.

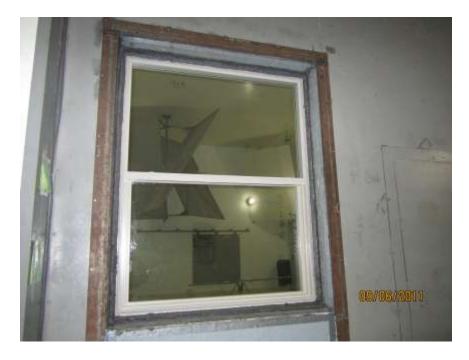
**Source Room View of Installed Test Specimen**
