### ASTM E 90 SOUND TRANSMISSION LOSS TEST REPORT

MI WINDOWS AND DOORS, INC.

SERIES/MODEL: 3500

**TYPE: Single Hung Window**

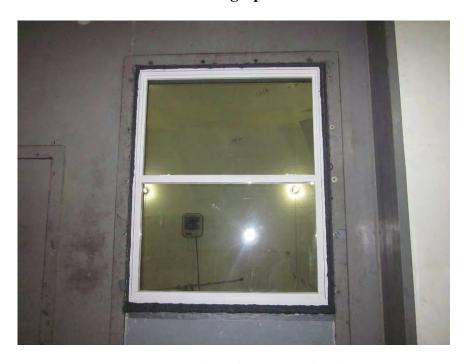
**Receive Room View of Installed Specimen**

A filler wall reducing element was used to reduce the test opening size. The reducing element consisted of two separate 2x6 wood frames filled with concrete to reduce the test opening size to 47-3/4" wide by 59-1/2" high. A dense neoprene gasket was placed between the two wood and concrete frames. The window was placed on an isolation pad in the new test opening. Duct seal was used to seal the perimeter of the window to the test opening on both sides. The interior side of the window frame, when installed, was approximately 1/4" from being flush with the receiving room side of the filler wall. A stethoscope was used to check for any abnormal air leaks around the test specimen prior to testing. The sash was opened and closed at least five times prior to testing.

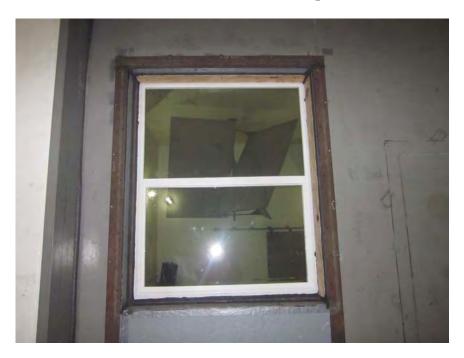
**Source Room View of Installed Specimen**
