F3232.01-113-11-R0
ACOUSTICAL PERFORMANCE TEST REPORT
ASTM E90

MI WINDOWS AND DOORS, LLC

Series/Model: 1685

Type: Horizontal Sliding Window

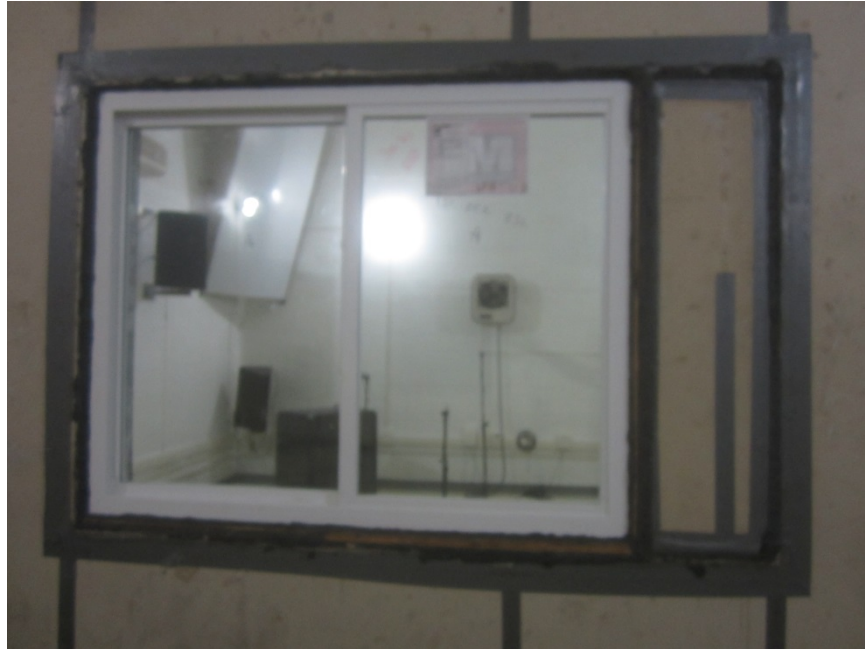
Receive Room View of Installed Specimen

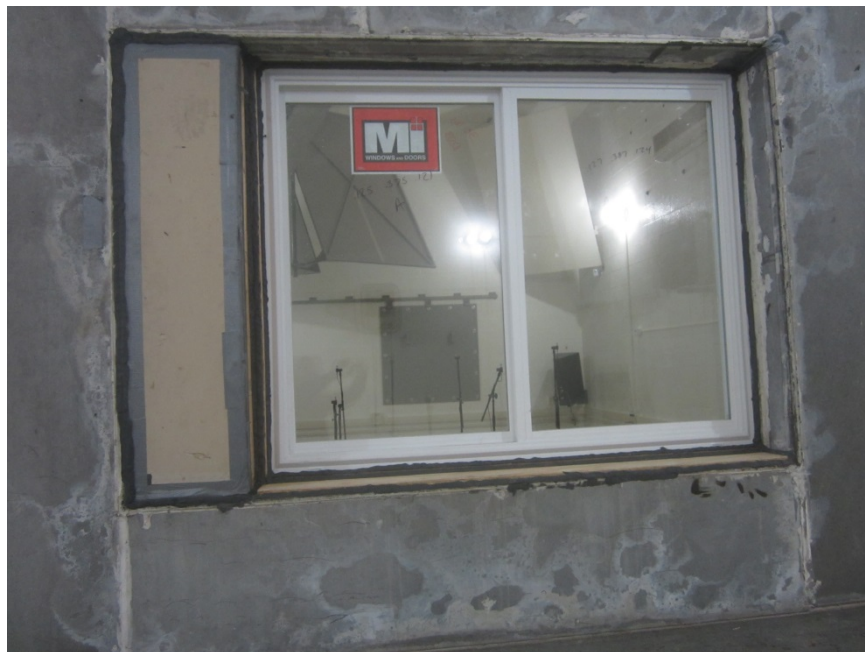
Source Room View of Installed Specimen
