ASTM E 90 SOUND TRANSMISSION LOSS TEST REPORT

MI WINDOWS AND DOORS, INC.

SERIES/MODEL: 3500/1255

TYPE: Single Hung Window

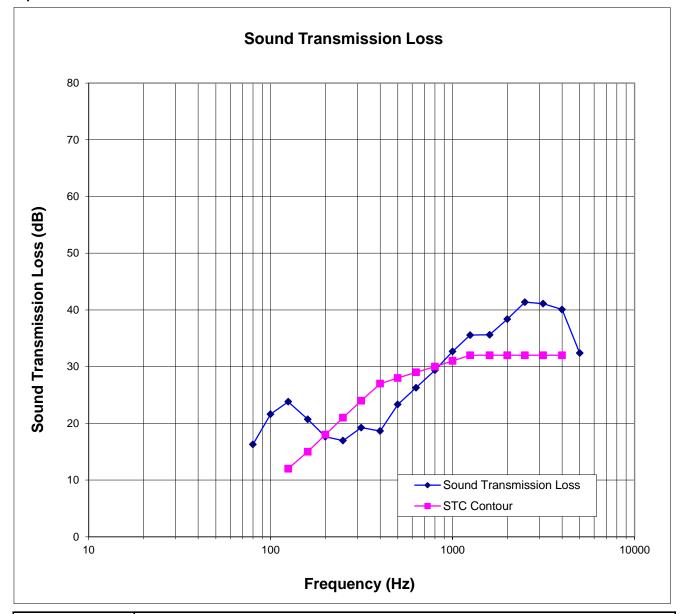
ATI No. B2697.01A **Date** 09/08/11

Specimen Series/Model: 3500/1255, single hung window with 3/4" IG (3/32" annealed, 9/16" air

space, 3/32" annealed)

Specimen Area 1.80 Square Meters **Filler Area** 11.20 Square Meters

STC Rating = 28 (Sound Transmission Class)

OITC Rating = 23 (Outdoor/Indoor Transmission Class)

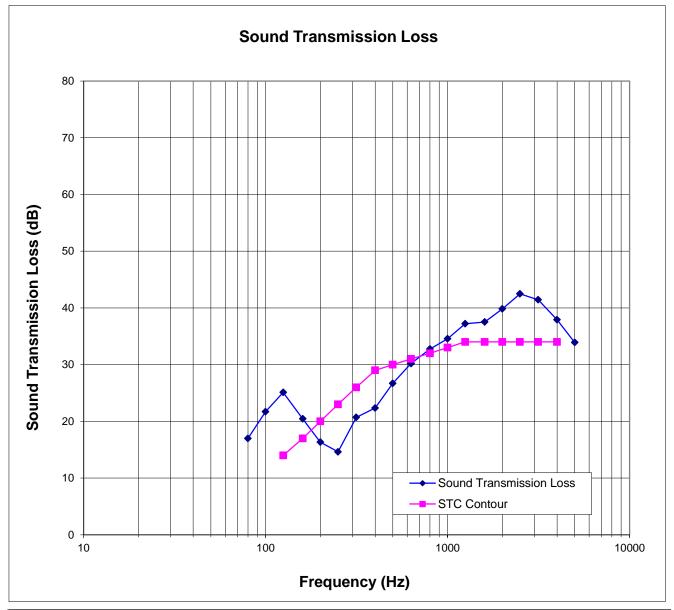
ATI No. B2697.01B **Date** 10/21/11

Specimen Series/Model: 3500/1255, single hung window with 7/8" IG (3/32" annealed exterior, 21/32"

air space, 1/8" annealed interior)

STC Rating = 30 (Sound Transmission Class)

OITC Rating = 24 (Outdoor/Indoor Transmission Class)

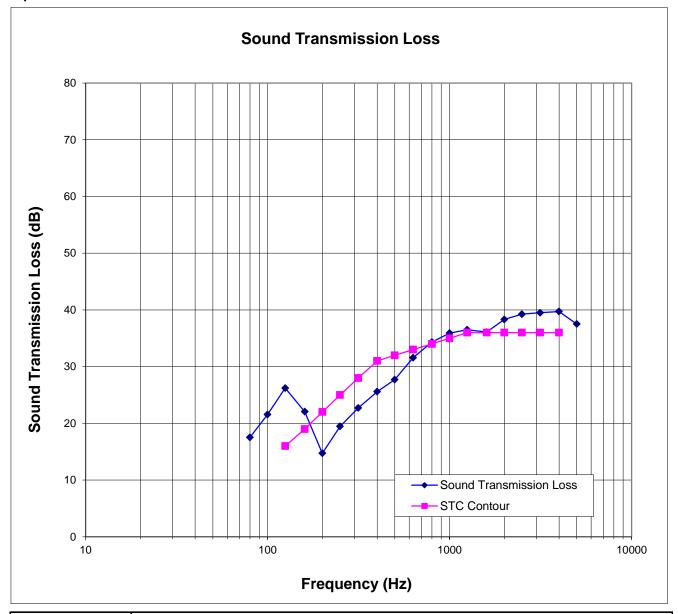
ATI No. B2697.01C **Date** 10/21/11

Specimen Series/Model: 3500/1255, single hung window with 7/8" IG (3/32" annealed exterior, 19/32"

air space, 3/16" annealed interior)

STC Rating = 32 (Sound Transmission Class)

OITC Rating = 25 (Outdoor/Indoor Transmission Class)

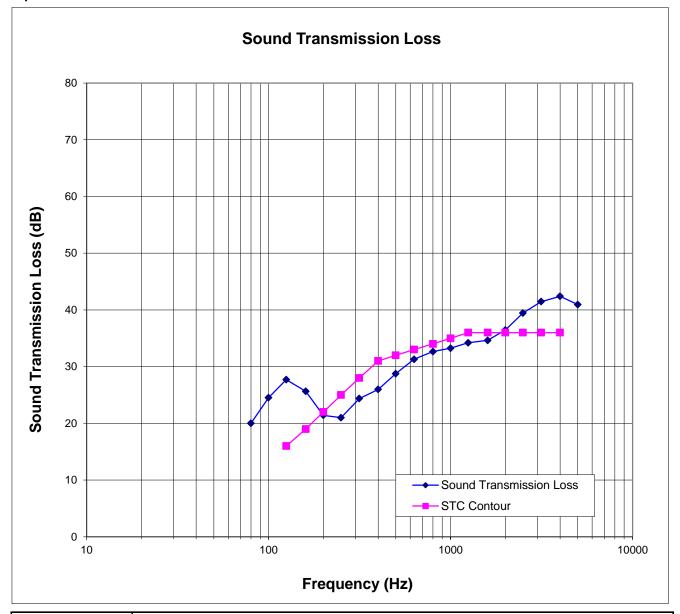
ATI No. B2697.01D **Date** 10/21/11

Specimen Series/Model: 3500/1255, single hung window with 7/8" IG (3/32" annealed exterior, 1/2" air

space, 9/32" [0.030"Q] laminated interior), Glass temperature 75°F

STC Rating = 32 (Sound Transmission Class)

OITC Rating = 28 (Outdoor/Indoor Transmission Class)

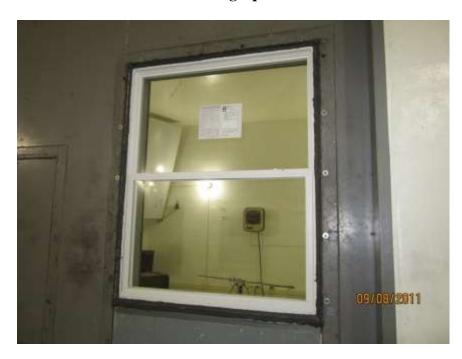
Receive Room View of Installed Specimen

A filler wall reducing element was used to reduce the test opening size. The reducing element consisted of two separate 2x6 wood frames filled with concrete to reduce the test opening size to accommodate the test specimen. A dense neoprene gasket was placed between the two wood and concrete frames. The window was placed on an isolation pad in the new test opening. Duct seal was used to seal the perimeter of the window to the test opening on both sides. The interior side of the window frame, when installed, was approximately 1/4" from being flush with the receiving room side of the filler wall. A stethoscope was used to check for any abnormal air leaks around the test specimen prior to testing. The vent was opened and closed at least five times prior to testing.

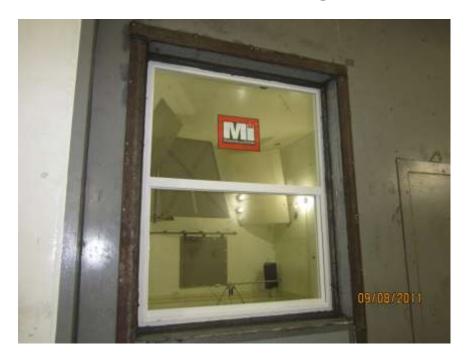
Source Room View of Installed Specimen
