F0213.01-113-11-R0
ACOUSTICAL PERFORMANCE TEST REPORT
ASTM E90

MI WINDOWS AND DOORS, LLC

Series/Model: 4300

Type: Polyvinyl Chloride (PVC) Single Hung Window

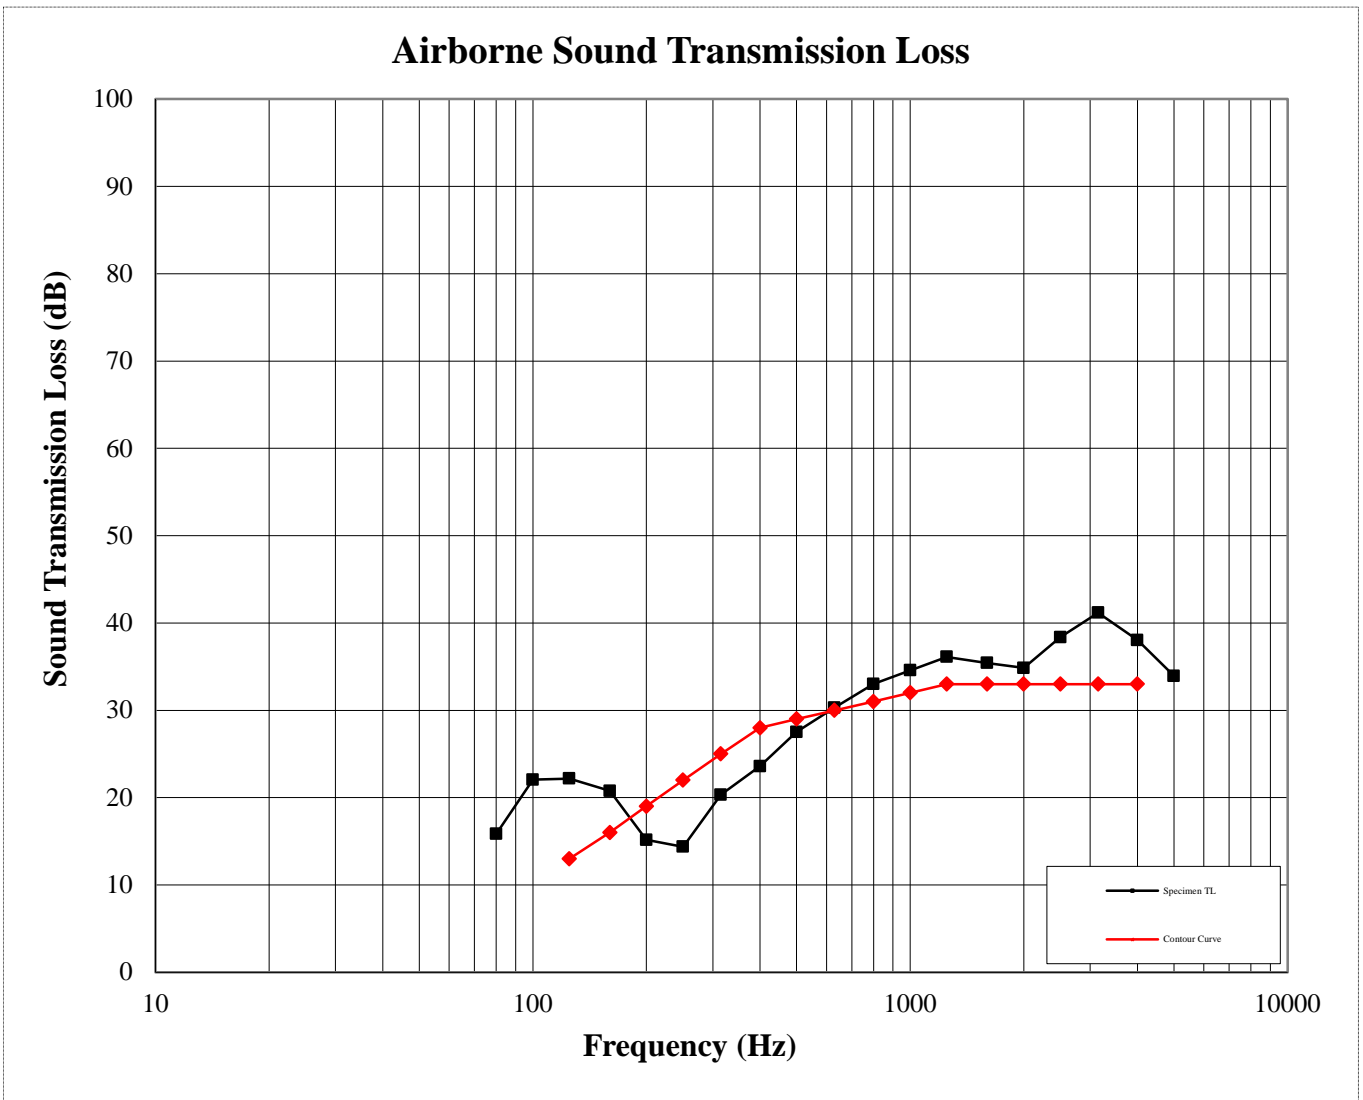
AIRBORNE SOUND TRANSMISSION LOSS
ASTM E 90

Test Date	08/27/15					
Data File No.	F0213.01B					
Client	MI Windows and Doors, LLC					
Description	Series/Model: 4300, Polyvinyl Chloride (PVC) Single Hung Window with 7/8" IG (3/32" annealed exterior, 21/32" air space, 1/8" annealed interior)					
Specimen Area	1.80 m ²	Receive Temp.	23.6 °C		Source Temp.	23.1 °C
Technician	Kurt A. Golden	Receive Humidity	52%		Source Humidity	51%

Freq (Hz)	Background SPL (dB)	Absorption (m ²)	Source SPL (dB)	Receive SPL (dB)	Specimen TL (dB)	95% Confidence Limit	Number of Deficiencies
80	39.7	5.3	105	85	15.8	2.41	-
100	36.0	5.3	105	78	22.1	1.87	-
125	39.3	4.8	104	78	22.2	1.14	0
160	44.5	4.4	104	79	20.8	1.15	0
200	41.7	4.7	106	86	15.2	0.75	4
250	35.6	5.3	105	86	14.4	0.91	8
315	28.4	5.5	98	73	20.3	0.40	5
400	25.4	5.8	95	66	23.6	0.48	4
500	22.1	5.9	95	63	27.5	0.33	1
630	19.7	5.5	100	65	30.3	0.27	0
800	17.5	5.7	99	61	33.0	0.20	0
1000	13.1	6.0	96	56	34.6	0.32	0
1250	9.9	6.7	97	55	36.1	0.25	0
1600	8.0	7.1	102	61	35.4	0.29	0
2000	6.0	7.3	94	53	34.8	0.30	0
2500	5.3	8.2	93	48	38.4	0.14	0
3150	5.5	9.9	95	46	41.2	0.16	0
4000	6.0	11.9	93	47	38.0	0.15	0
5000	6.7	15.0	92	49	33.9	0.18	-

STC Rating **29** *(Sound Transmission Class)*
Deficiencies **22** *(Sum of Deficiencies)*
OITC Rating **23** *(Outdoor-Indoor Transmission Class)*

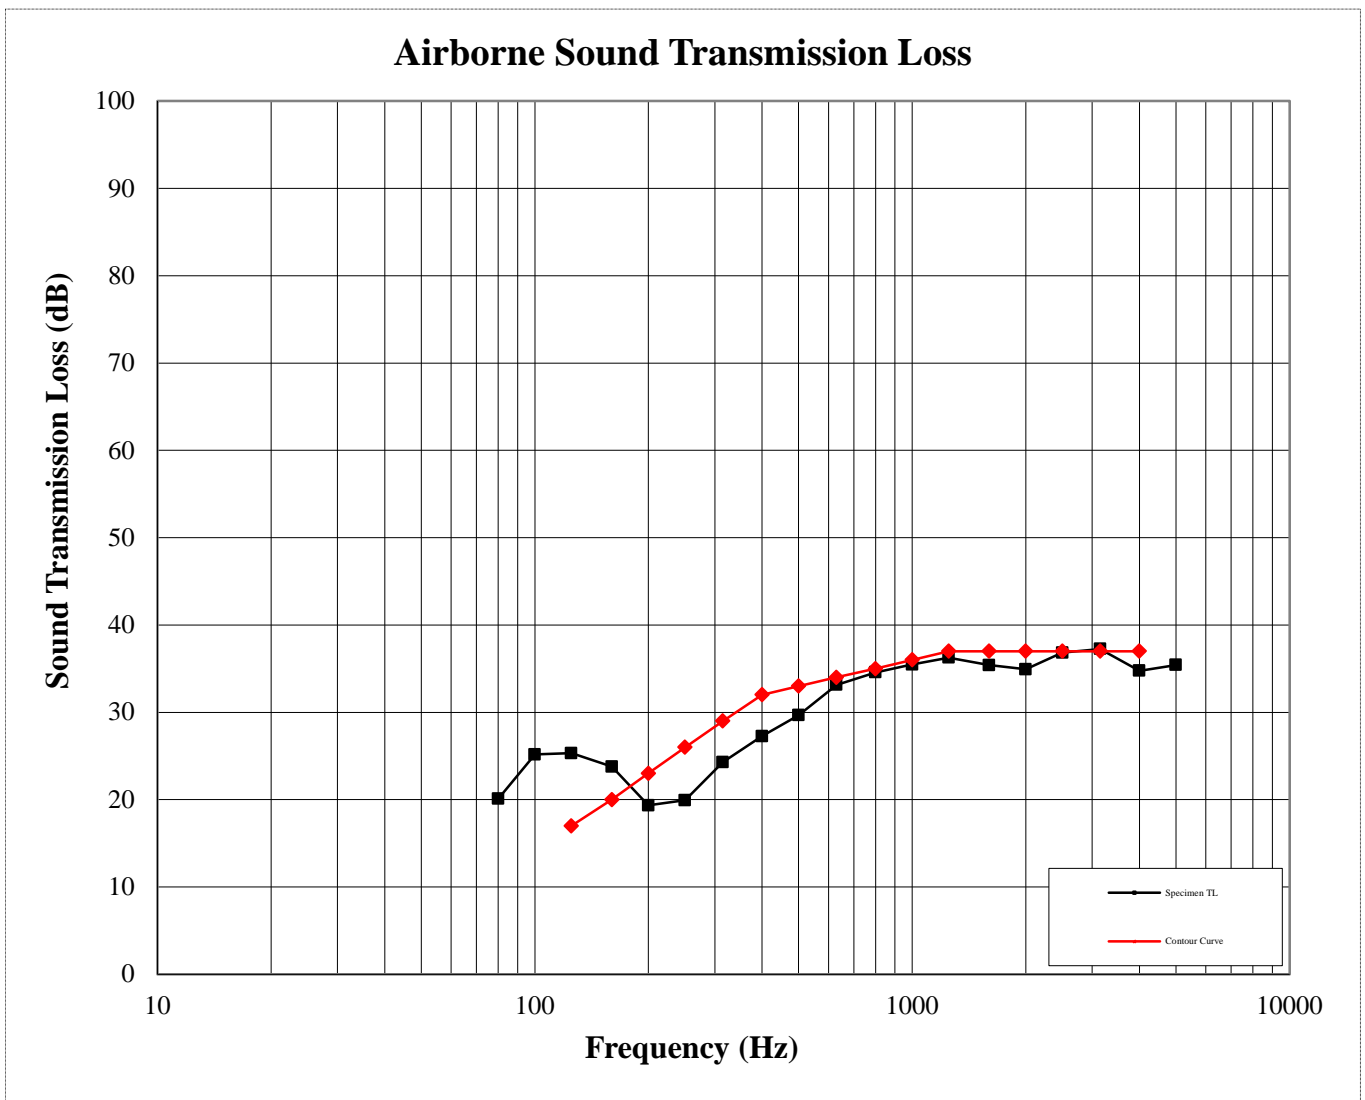
AIRBORNE SOUND TRANSMISSION LOSS

Test Date	08/27/15					
Data File No.	F0213.01D					
Client	MI Windows and Doors, LLC					
Description	Series/Model: 4300, Polyvinyl Chloride (PVC) Single Hung Window with 7/8" IG (1/8" annealed exterior, 9/16" air space, 3/16" annealed interior)					
Specimen Area	1.80 m ²	Receive Temp.	22.8 °C		Source Temp.	23.1 °C
Technician	Kurt A. Golden	Receive Humidity	52%		Source Humidity	52%

Freq (Hz)	Background SPL (dB)	Absorption (m ²)	Source SPL (dB)	Receive SPL (dB)	Specimen TL (dB)	95% Confidence Limit	Number of Deficiencies
80	39.7	4.8	105	82	20.1	2.15	-
100	36.7	5.1	105	76	25.2	1.62	-
125	38.3	4.4	105	76	25.3	1.35	0
160	42.8	4.5	104	76	23.8	1.23	0
200	39.7	4.5	106	83	19.3	0.83	4
250	34.5	5.2	105	81	19.9	1.02	6
315	27.0	5.4	99	69	24.3	0.53	5
400	24.5	5.7	95	62	27.3	0.40	5
500	20.9	5.8	95	61	29.7	0.34	3
630	19.0	5.5	100	62	33.1	0.32	1
800	16.0	5.7	99	60	34.6	0.43	0
1000	12.3	5.9	96	56	35.5	0.36	1
1250	9.1	6.6	97	55	36.3	0.23	1
1600	7.6	7.0	102	61	35.4	0.25	2
2000	5.9	7.4	95	54	34.9	0.21	2
2500	5.4	8.3	93	49	36.8	0.18	0
3150	5.6	9.9	95	50	37.3	0.13	0
4000	6.1	12.2	93	50	34.8	0.21	2
5000	6.7	15.4	92	47	35.4	0.22	-

STC Rating **33** *(Sound Transmission Class)*
Deficiencies **32** *(Sum of Deficiencies)*
OITC Rating **27** *(Outdoor-Indoor Transmission Class)*

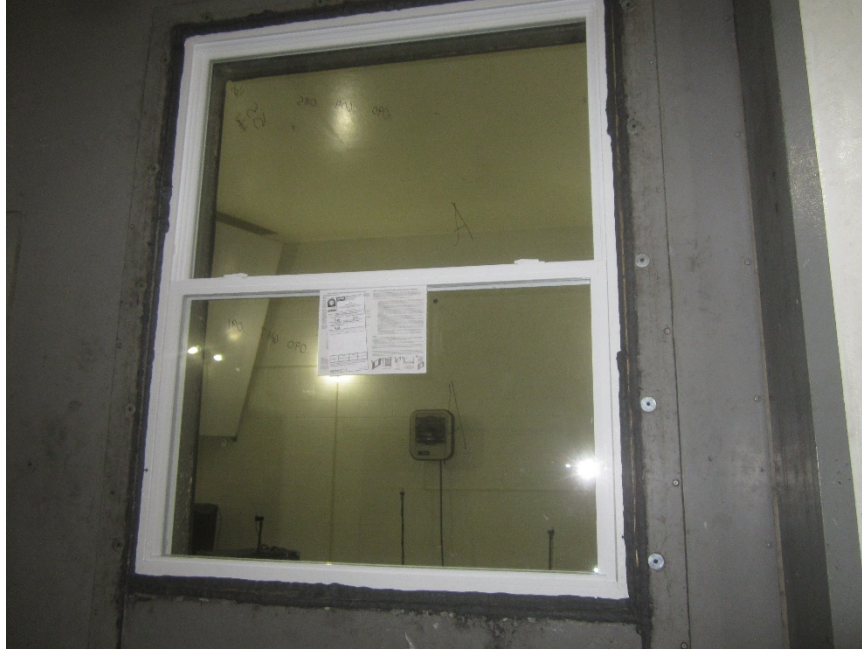
Receive Room View of Installed Test Specimen

The specimen plug was removed from the filler wall assembly. A filler wall-reducing element, consisting of two separate 2x6 wood frames filled with concrete, was used to adjust the test opening size to accommodate the test specimen. A dense neoprene gasket was placed between the two wood and concrete frames. The specimen was placed on an isolation pad in the custom test opening. Duct seal was used to seal the perimeter of the specimen to the test opening on both sides. The interior side of the specimen, when installed, was approximately 1/4" from being flush with the receive room side of the filler wall. A stethoscope was used to check for any abnormal air leaks around the test specimen prior to testing. Operable portions of the test specimen, if any, were cycled at least five times prior to testing.

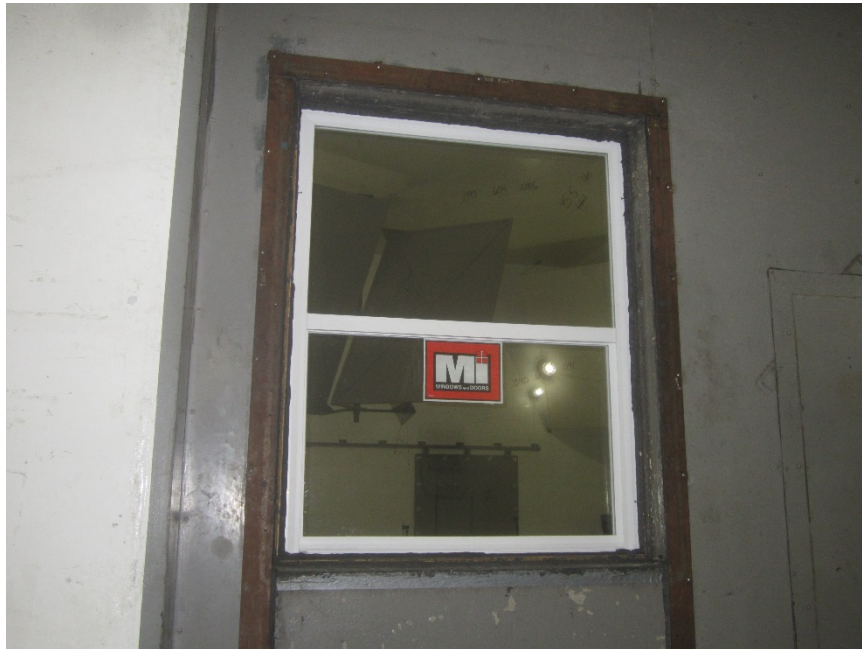
Source Room View of Installed Test Specimen
